**COBBLESTONE HOMEOWNERS
ASSOCIATION
INDIAN LAND, SC**

SEPTEMBER 18, 2020

FULL RESERVE STUDY

GILES & FLYTHE
ENGINEERS

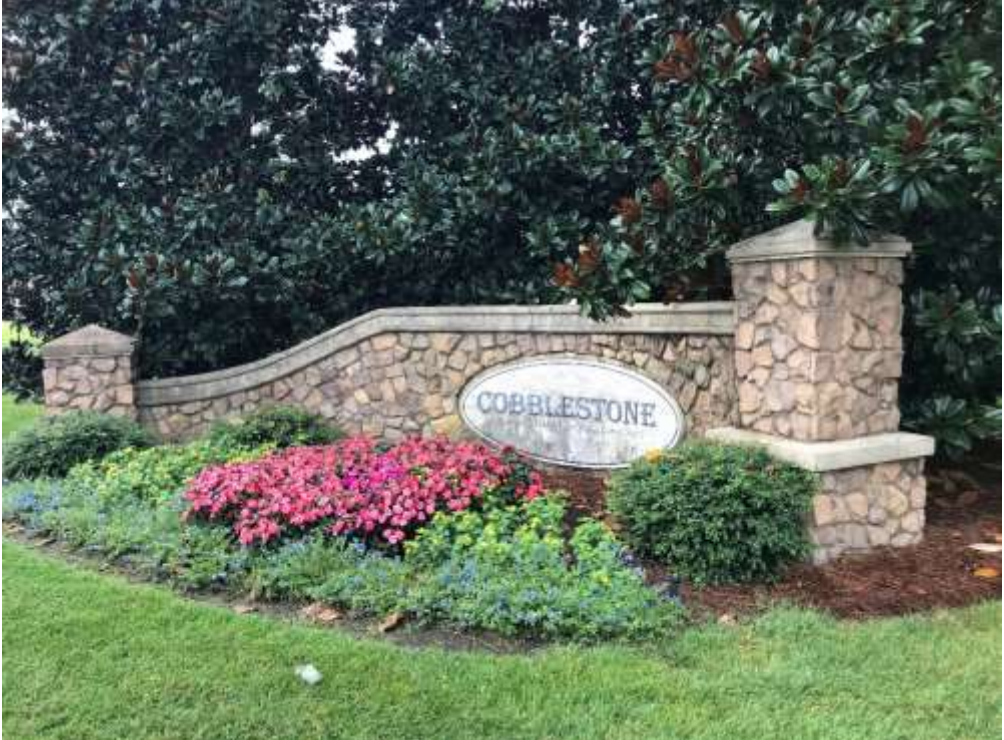
<p>Photo No. 1</p>

<p>Description Entrance monument</p>

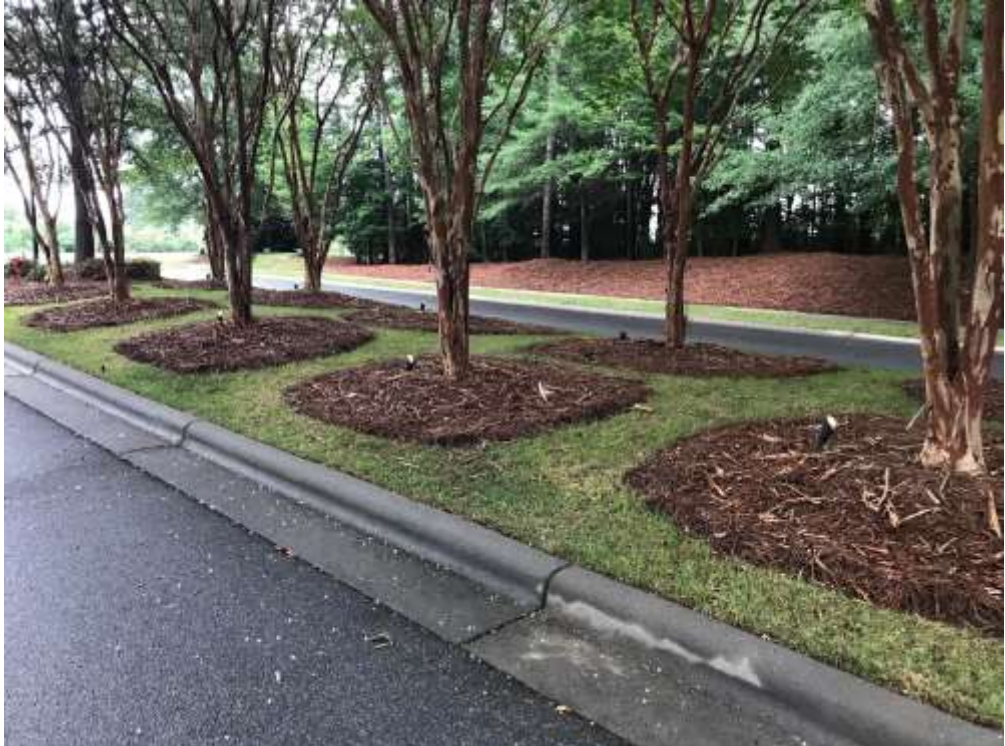
<p>Description Typical landscape lighting at entrance</p>

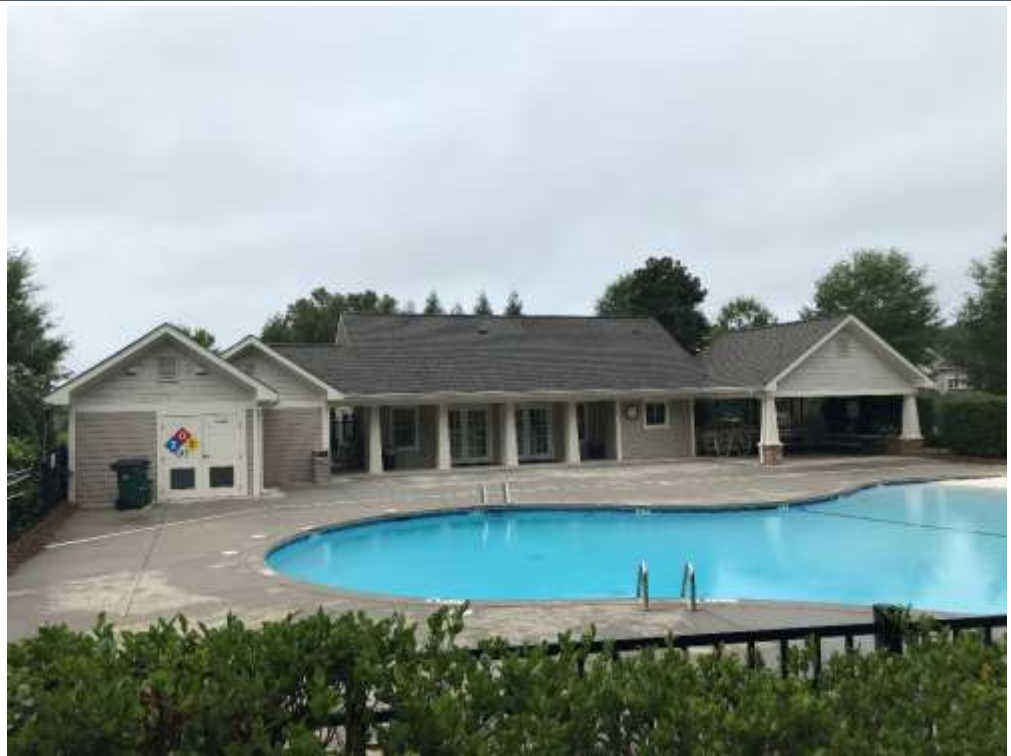
Photo No.
5

Rear elevation of
clubhouse

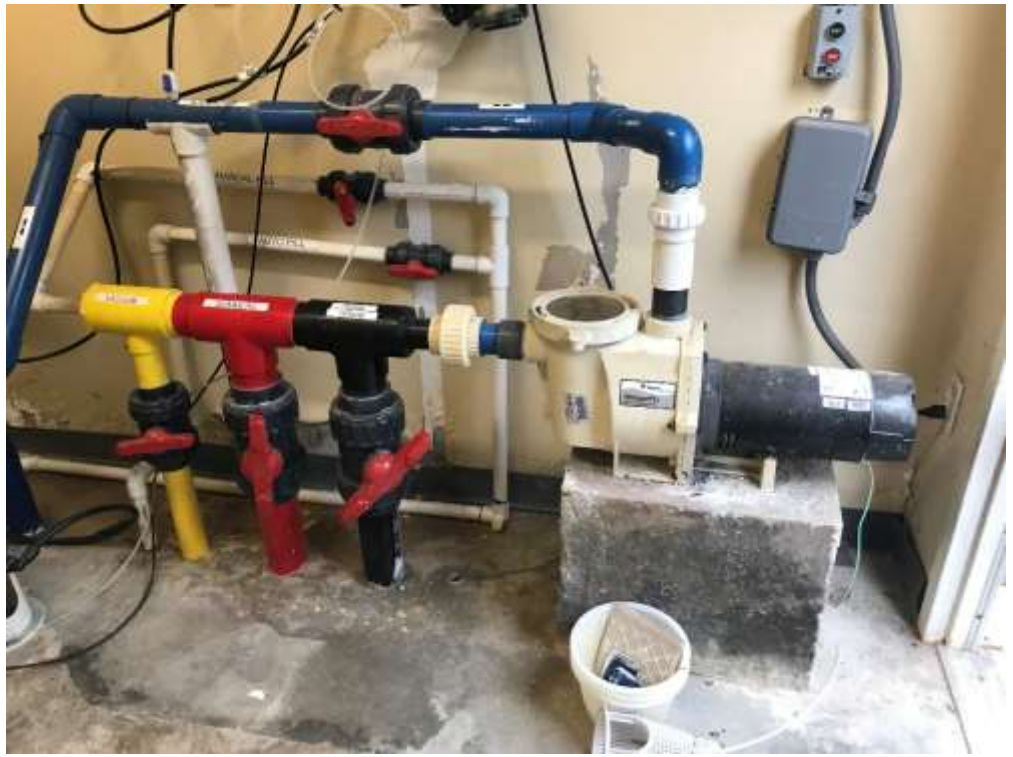
Photo No.
9

Description
Pool pump equipment

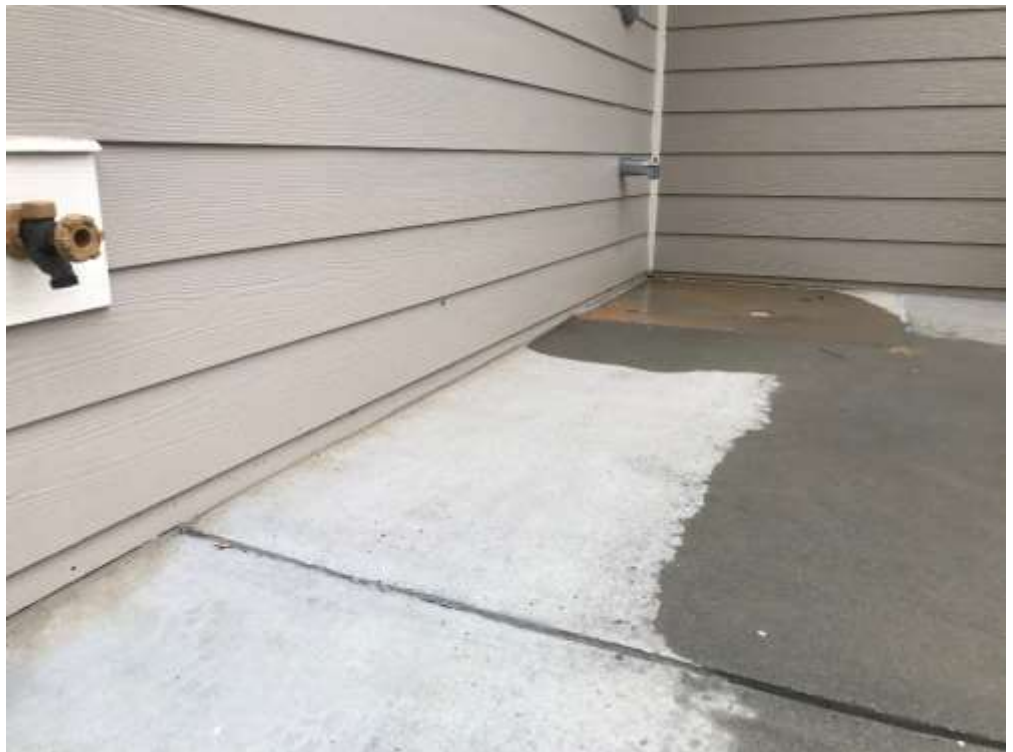
Photo No.
10

At the time of the site inspection, moisture infiltration was observed at the exterior clubhouse bathroom adjacent to the outside shower drain. We have allocated funds to repair the building flashing, siding, and damaged interior bathroom finishes in 2021.

Description
Moisture infiltration
area at clubhouse
bathroom adjacent to
shower

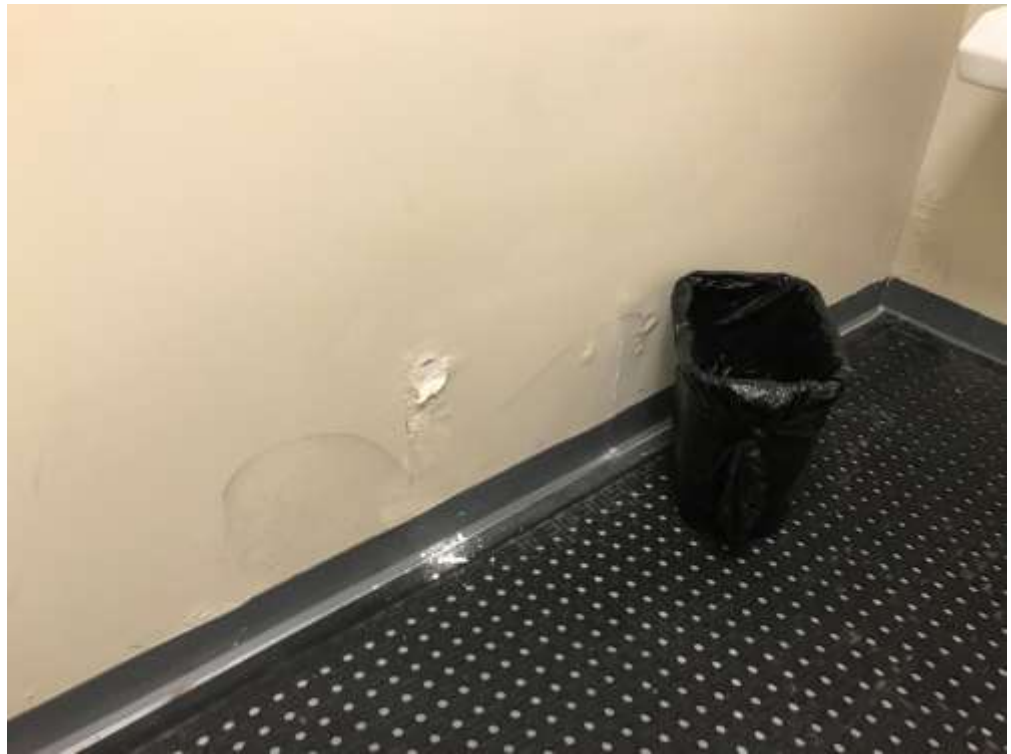
Photo No.
11

Damaged bathroom
finish materials at
shower area infiltration

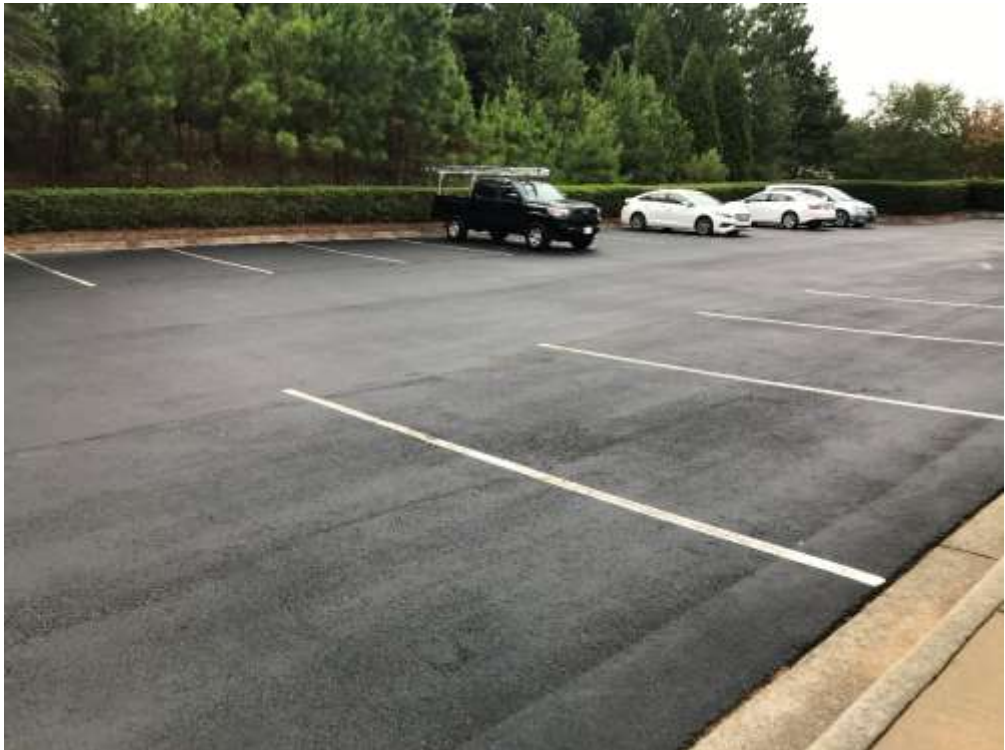
<p>Photo No. 16</p>

The drive and parking area adjacent to the community clubhouse are asphalt paved and maintained by the Master association. The streets adjacent to the townhomes (Crown Vista Drive and Chasewater Drive) are asphalt paved and maintained by the Townhome association. The remaining streets providing access into the community and adjacent to the single-family homes are reportedly public and not maintained by the association. The paving generally appeared to be in relatively good condition with minor longitudinal/transverse cracks observed. Typically, we recommend the application of an oil resistant sealant to all asphalt paved surfaces on an approximate 7-year cycle. At this time, all cracks should be properly filled, patched, and sealed. We have allocated funds to seal all the paved surfaces (Townhome streets and clubhouse parking) beginning in 2023.

<p>Description Clubhouse parking lot</p>

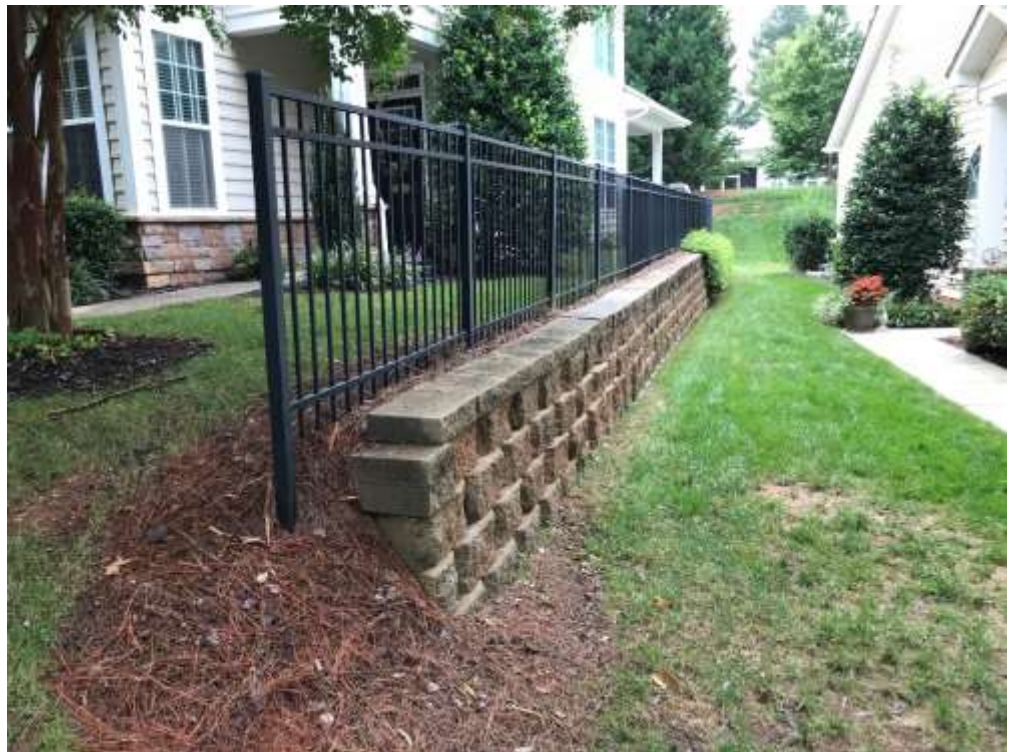
Photo No.
24

Multiple retaining walls were noted throughout the community. Retaining walls are installed in areas to address topographical change. Walls observed consisted of reinforced segmental block. The segmental block walls generally appeared to be in good condition with isolated areas of separation observed between the blocks. Provided the walls were installed with adequate reinforcement and drainage components, the segmental block retaining walls have an expected useful life beyond the term of this study. We recommend monitoring the retaining walls with separation between the blocks for additional movement. If additional movement is observed, further evaluation by a structural engineer should be conducted. We have assumed minor repairs to the segmental block wall will be funded from the annual maintenance budget and/or the drainage improvements allocation noted above.

Typical segmental block
retaining wall with
aluminum fencing

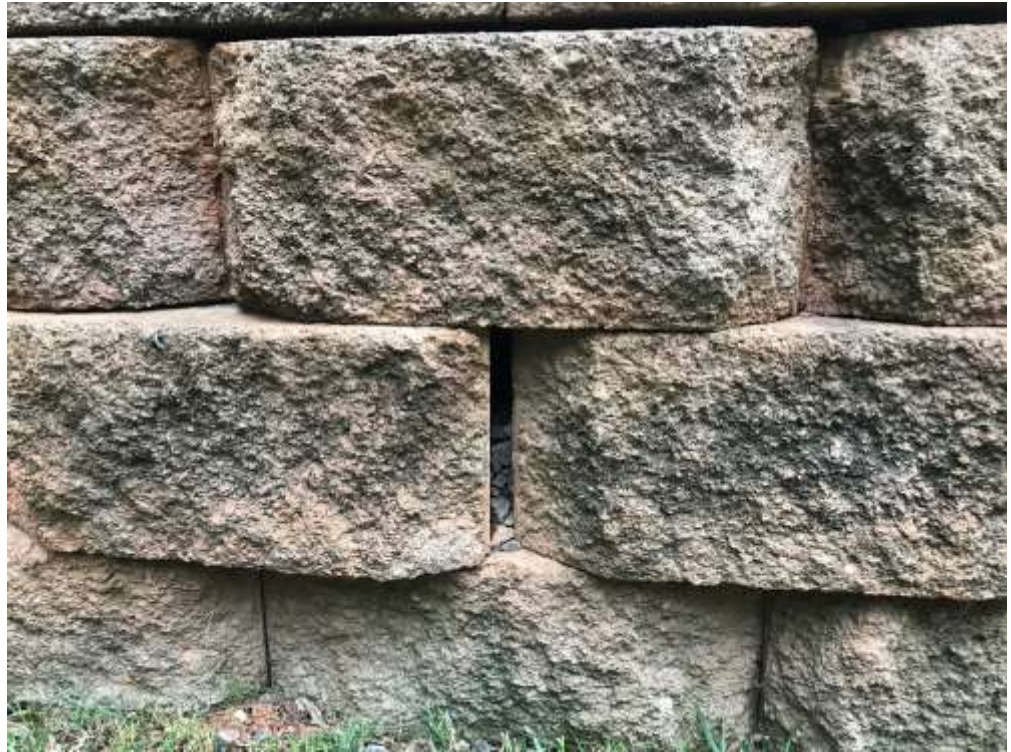
Photo No.
25

Isolated separation of retaining wall blocks

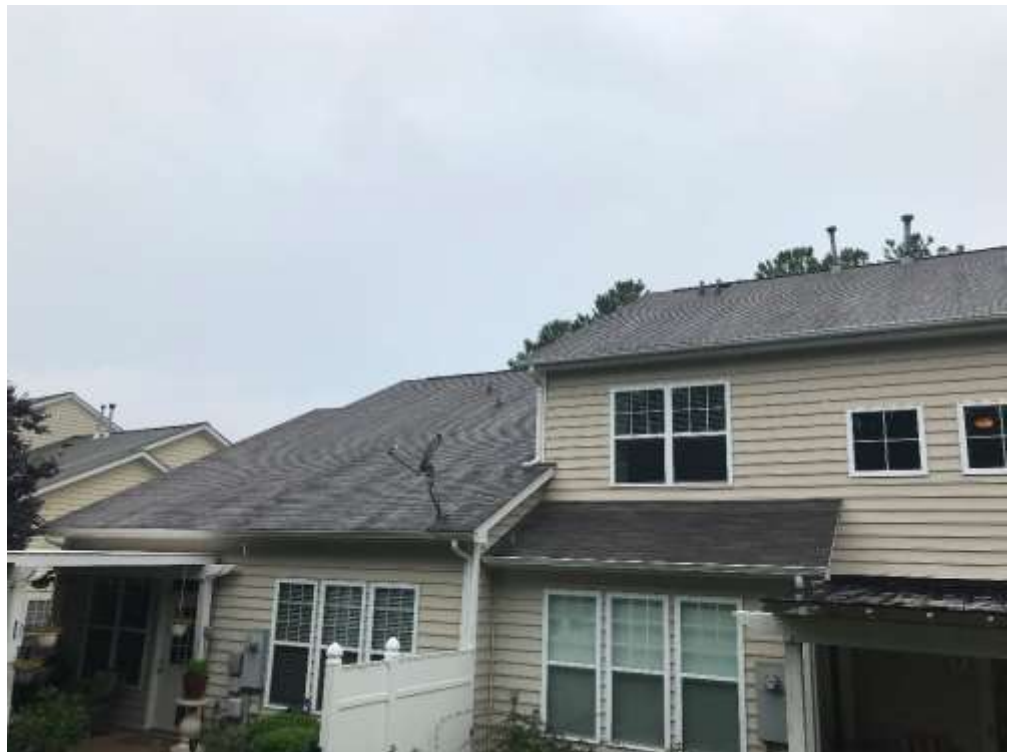
Photo No.
26

The predominant pitched roof surfaces over the clubhouse building are covered in asphaltic fiberglass, architectural grade shingles. Roof surfaces over the townhome buildings were covered in asphaltic fiberglass, 3-tab shingles. Roof surfacing is applied over roof sheathing and appears to be in good condition. Minor repairs over the term will likely include replacing vent boots, flashing and drip edge repairs, and gutter repairs. We have assumed these types of repairs would be funded from an annual maintenance budget.

Typical townhome building roofing

If inspections and minor repairs occur in the interim, typical architectural grade shingle roofs will last approximately twenty-five years. Typical 3-tab shingles will last approximately twenty years. We have allocated funds to replace the townhome building roofs in three phases beginning in 2028, 2029, and 2030 (generally consistent with the age of construction of the buildings). We have allocated funds to replace the clubhouse roof in 2033. We have allocated funds to replace roofing on the gatehouse in conjunction with the clubhouse roofing. Additionally, we have allocated funds to replace the roofing on the mailbox center in conjunction with the townhomes. We strongly recommend that any re-roofing project closely follow procedures outlined by the National Roofing Contractors Association's *Roofing and Waterproofing Manual*. A re-roofing sequence should include removal of the existing roofing material, replacement of any inadequate roof sheathing, replacement of any damaged flashing, and replacement of drip edge components.

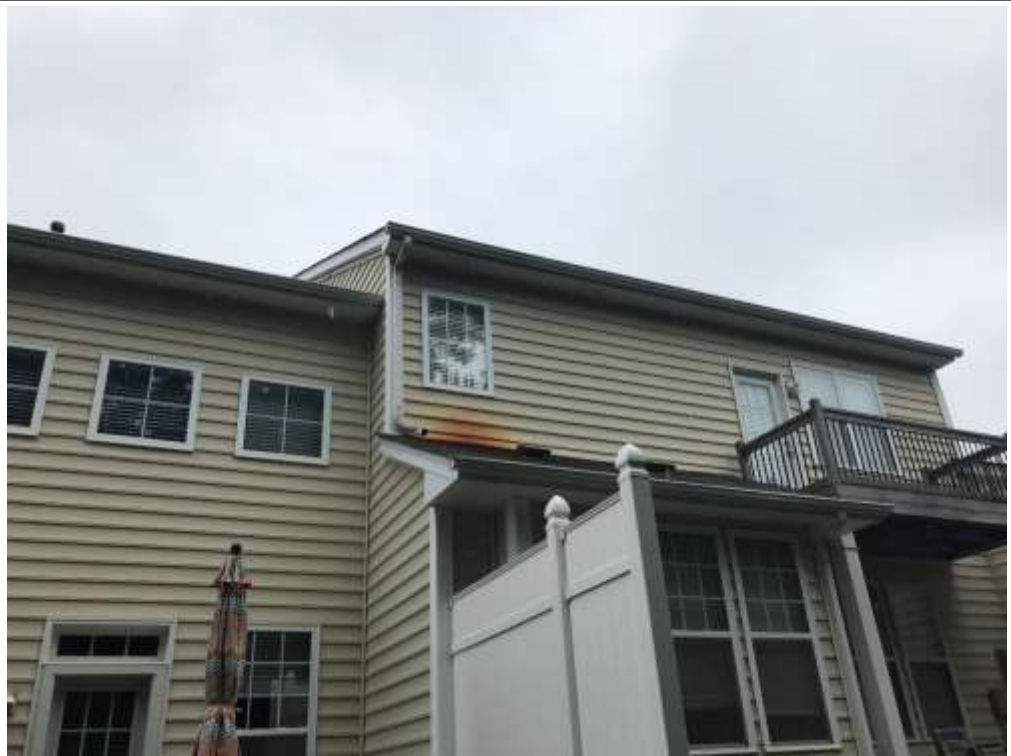
Photo No.
27

Typical isolated areas of stained siding observed

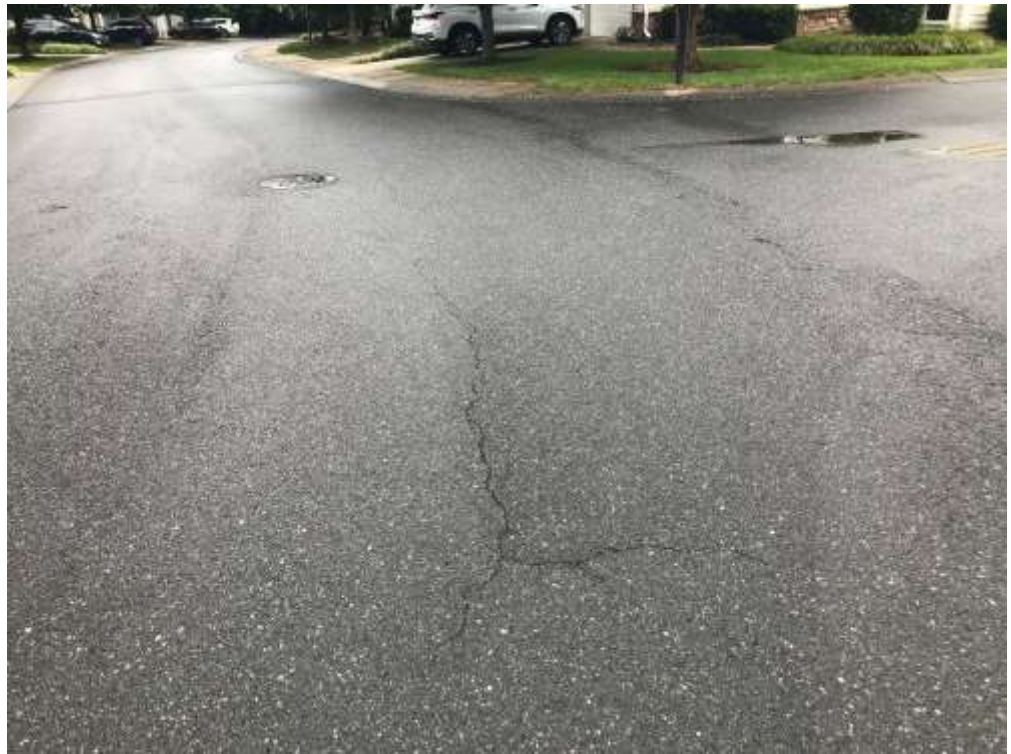
Photo No.
33

Assuming sealing and crack repairs occur in the interim, asphalt paving generally has an estimated useful life of approximately twenty years prior to full resurfacing. We have allocated funds to resurface (approximately 1-1½ inch thick overlay) the asphalt paving (Townhome streets and clubhouse parking) in 2031. To maintain adequate sheet flow and a consistent surface, note that resurfacing streets will likely require some milling prior to installing an additional overlay. The parking lot may require full milling to maintain adequate drainage.

Longitudinal/transverse
cracks in asphalt paved
streets at townhomes

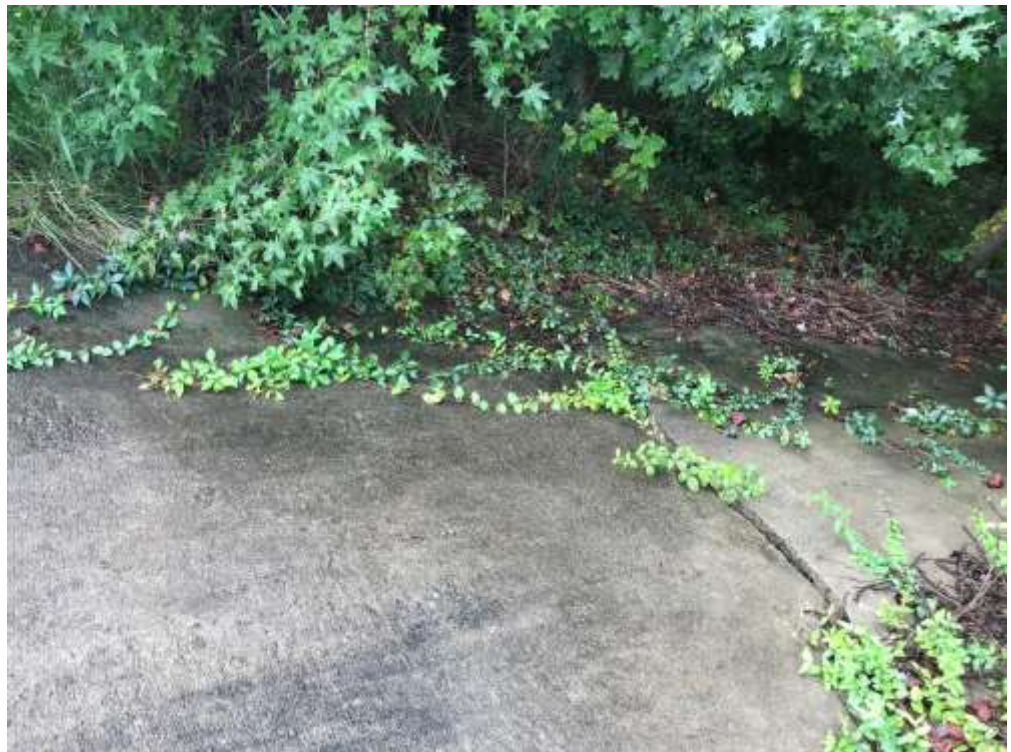
Photo No.
36

Storm water flows from the paving and site areas to curb inlet basins and catch basins in the paved/landscaped areas. The stormwater is generally routed to the two storm water control devices (ponds) in the community. The north most pond in the community is located near the southwest end of Crown Vista Drive. The south most pond is located near the intersection of Streamhaven Drive and Ridgeline Lane. The north most retention pond incorporated a concrete riser structure, rip rap armored HDPE inlet pipes, and a concrete emergency spillway. Large cracks and vertical displacement (up to 1-1/2") of the concrete spillway were observed at the north most pond dam. The association should strongly consider inspection and evaluations of the spillway by a qualified geo-technical engineer to determine repairs required. The south most retention pond incorporated a concrete riser structure, rip rap armored HDPE inlet pipes, and a concrete headwall outlet structure with a rip rap armored swale on the west side of Streamhaven. Shoreline erosion was noted along the perimeter of the south pond and accumulated sediment/debris were observed adjacent to the riser and outlet structures. We have provided a moderate allocation to prepare for repair expenses in 2023. Repairs may include dredging, shoreline stabilization, spillway, and outlet repairs. We have not allocated funds for substantial repairs to the earthen dams, if required. Also, we strongly encourage the association to contract with a pond maintenance

View of displaced area
of concrete spillway

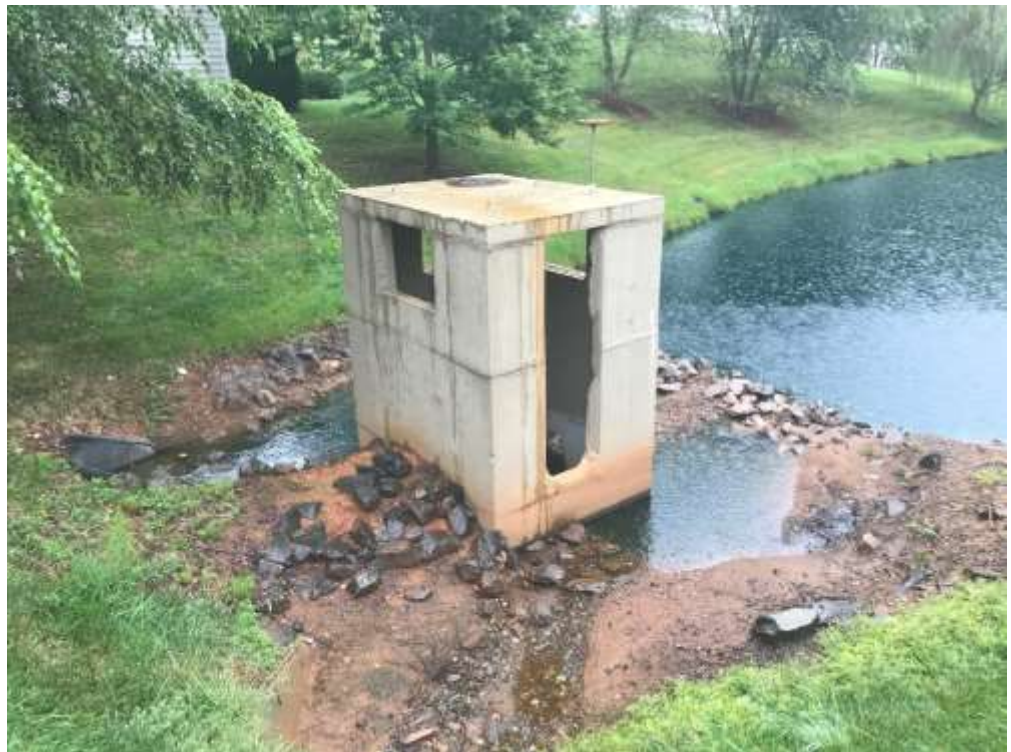
Photo No.
38

Accumulated sediment
near riser structure of
pond near corner of
Streamhaven Drive &
Ridgeline Lane

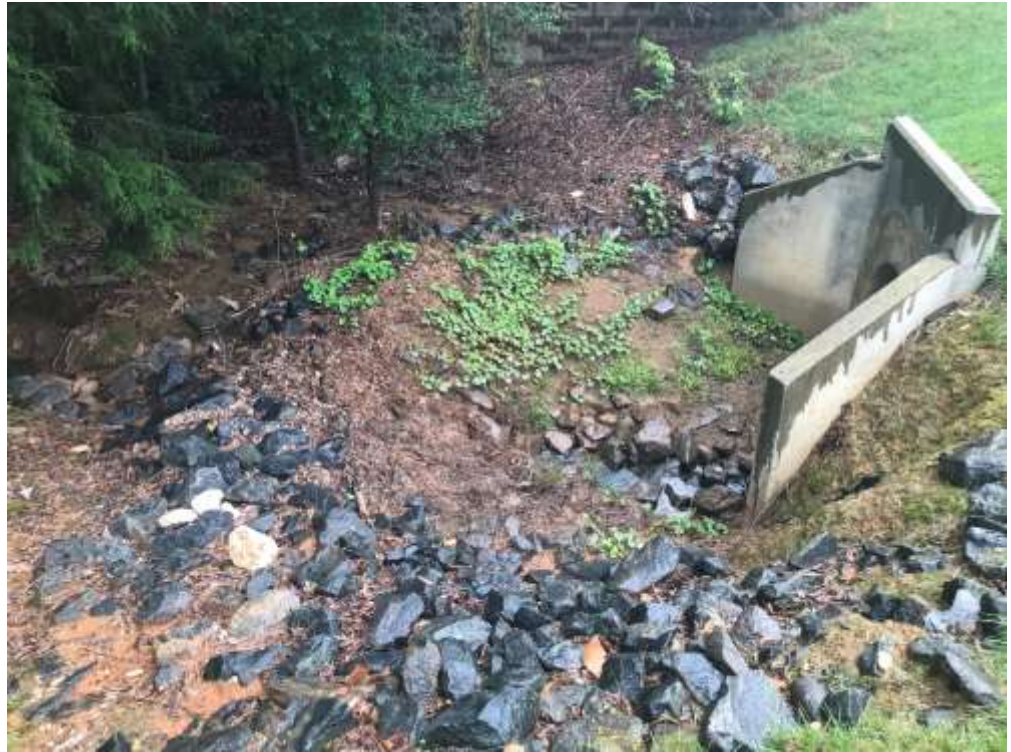
Photo No.
41

Accumulated sediment and debris at outlet structure of pond near corner of Streamhaven Drive & Ridgeline Lane

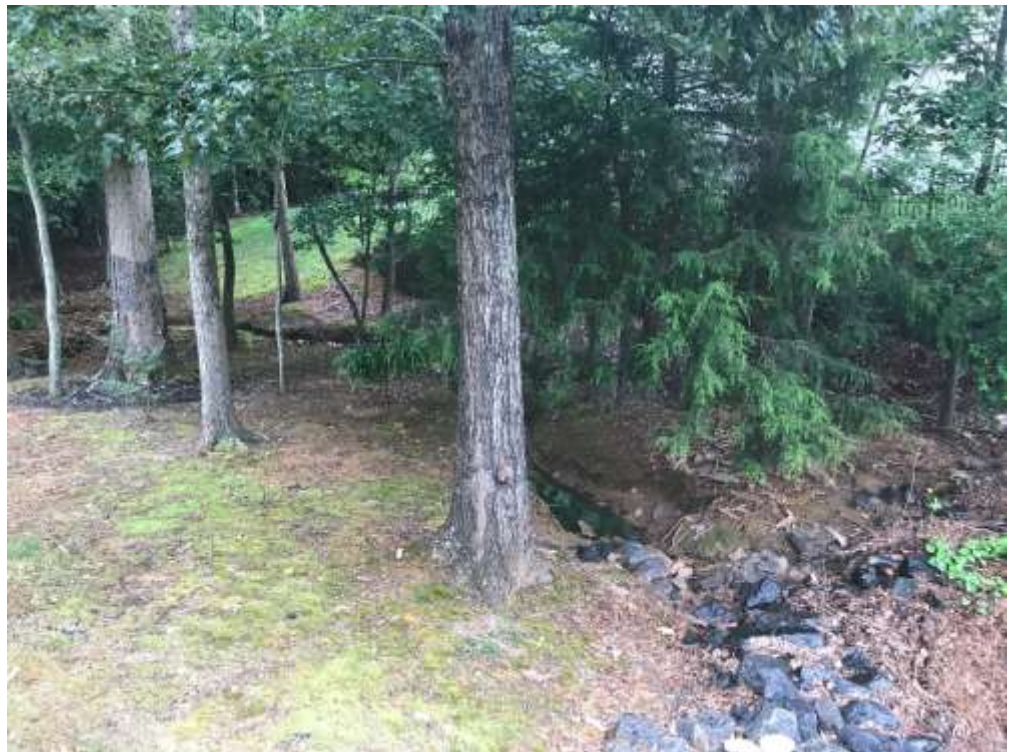
Photo No.
42

Rip rap reinforced swale downstream of pond outlet structure
